PENNSYLVANIA
HINCKSTON RUN DAM

NDS LD. No. PA - 00430
PENNDER LD. No. 11 - 9

PHASE I INSPECTION REPORT
NATIONAL DAM INSPECTION PROGRAM

GAI CONSULTANTS, INC.
570 BEATTY ROAD
MONROEVILLE, PENNSYLVANIA 15146
SEPTEMBER 1979

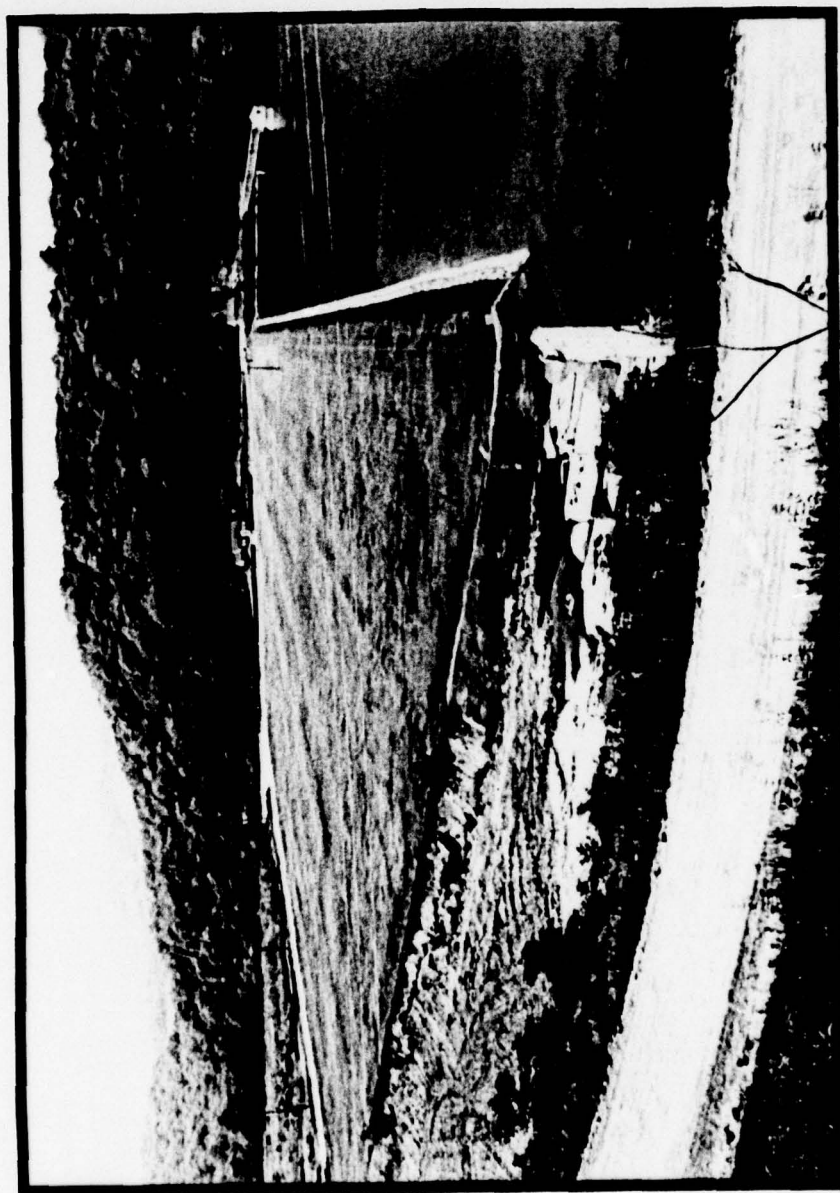
OVERVIEW PHOTOGRAPH

The facility is unique in that the downstream shell area has been utilized as a slag dump (see Figure 3), which has resulted in a minimum embankment crest width of 360 feet (see Overview Photograph and Figure 1).

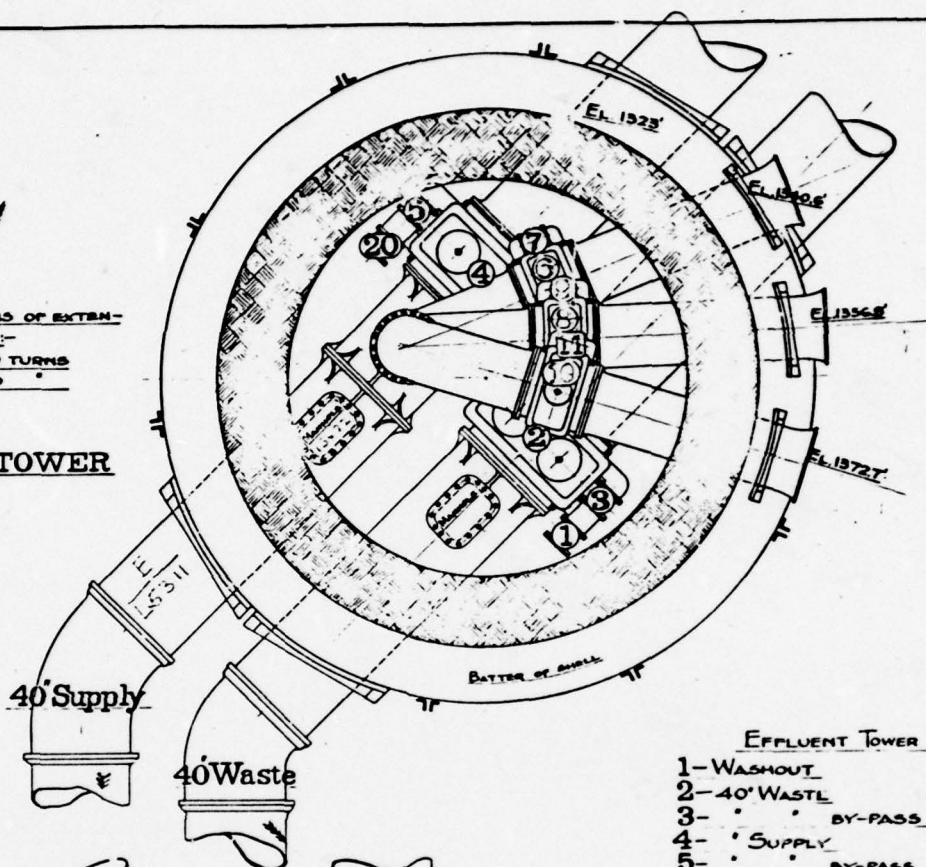
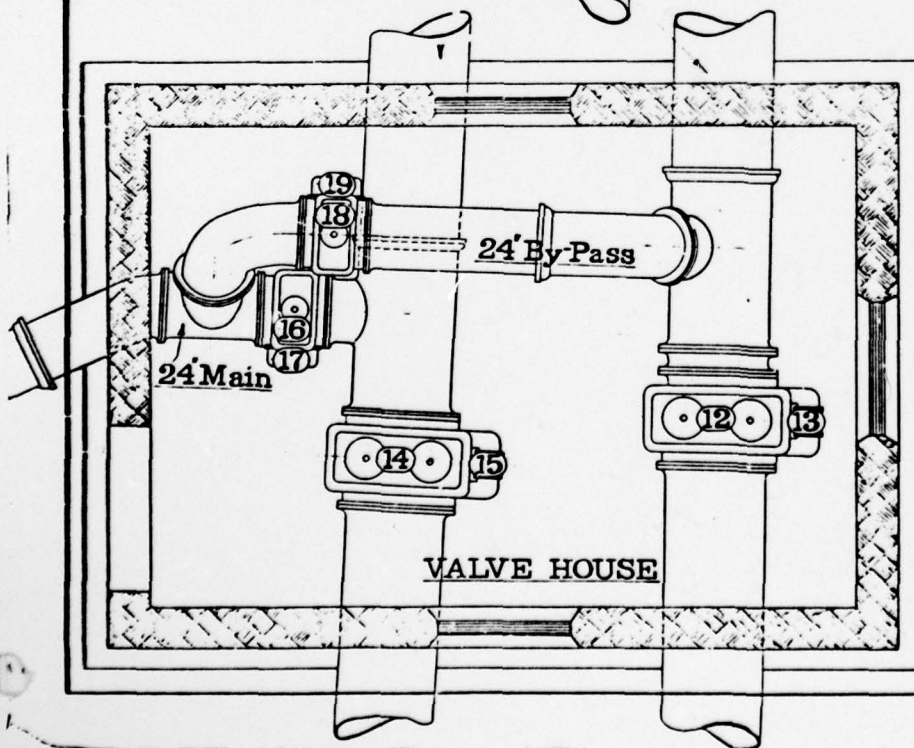
FIGURE 6

Valves are located within intake tower, but are reportedly inoperable. Control is provided by valves in downstream valve house (see Figure 6).

b. Outlet Works. The outlet works are composed of an intake tower, concrete encased conduits, and a downstream valve house. The intake tower is a cylindrical steel shell (varying from 19 to 23 feet in diameter) which is lined with concrete, and rests on a 28-foot diameter, 7-foot thick masonry foundation. It is located along the upstream toe of the embankment about 200 feet from the right (west) end of the dam. Within the tower, at the operating floor level, are five valve stands previously used to control intake levels and blowoff operation (see Figure 6 and Photograph 9). Modifications have been made to the intakes and all remaining valves are reportedly opened, but probably inoperable.
